DEPARTMENT OF TRANSPORTATION

Contract #: 04-0120F4Cty: SF/ALA Rte: 80 PM: 13.2/13.9File #: 13.28**WELDING INSPECTION REPORT****Resident Engineer:**Pursell, Gary**Address:** 333 Burma Road**City:** Oakland, CA 94607**Report No:** WIR-008903**Date Inspected:** 11-Sep-2009**Project Name:** SAS Superstructure**OSM Arrival Time:** 1300**Prime Contractor:** American Bridge/Fluor Enterprises, a JV**OSM Departure Time:** 2130**Contractor:** Oregon Iron Works Clackamas, Or.**Location:** Clackamas, OR**CWI Name:** Mike Gregson, Jose Salazar**CWI Present:** Yes No**Inspected CWI report:** Yes No N/A**Rod Oven in Use:** Yes No N/A**Electrode to specification:** Yes No N/A**Weld Procedures Followed:** Yes No N/A**Qualified Welders:** Yes No N/A**Verified Joint Fit-up:** Yes No N/A**Approved Drawings:** Yes No N/A**Approved WPS:** Yes No N/A**Delayed / Cancelled:** Yes No N/A**Bridge No:** 34-0006**Component:** Hinge K Pipe Beams**Summary of Items Observed:**

Hinge-K Pipe Beam Assembly 102A-1: 9/11/09

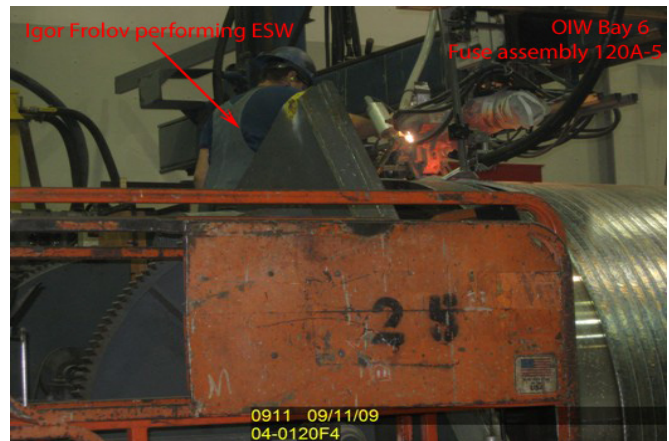
Hinge-K Pipe Beam Fuse Assembly 120A-5: 9/11/09

QA Inspector noticed that the first ESW stainless steel overlay passes were in-process, on this fuse assembly 120A-5. QA Inspector witnessed welder #F17, Mr. Igor Frolov performing electro slag welding (ESW) on the first layer welding passes, (approximately 95% complete), in the flat position, utilizing Soudokay brand Soudotape 309L stainless steel consumable strip. QA Inspector noted the first layer passes would be completed utilizing the 309L consumable strip and the remaining second & third layer passes would be completed utilizing Soudokay brand Soudotape 316L stainless steel consumable strip, per contract requirements. QA Inspector randomly noticed QC Inspector's Mike Gregson and Jose Salazar were present, to verify in-process welding parameters (amps/volts) and monitor in-process continuous pre-heat temperatures. QA Inspector spoke with QC Inspector Jose Salazar and Mr. Salazar explained that welding amps were recorded as 1200 amps/25.2 volts, travel speed at 269mm/min. and a pre-heat temperature recorded at 225 Fahrenheit (107 C). QA Inspector verified in-process welding parameters of 1200 amps/25.2 volts and recorded pre-heat temperatures of approximately 225 Fahrenheit (107 C) QA

Inspector verified Mr. Igor Frolov was currently qualified for this welding process/position and randomly recorded pre-heat temperatures of approximately 225 Fahrenheit. QA Inspector noted that Mr. Igor Frolov appeared to be in compliance with the applicable approved welding procedure specification (WPS 7003). See attached picture below.
